Solving Moisture Mysteries With an Infrared Camera

Water leaks aren't always where you think they are

by Peter Hopkins

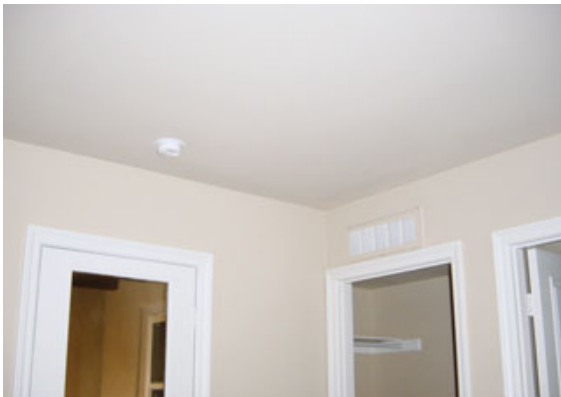
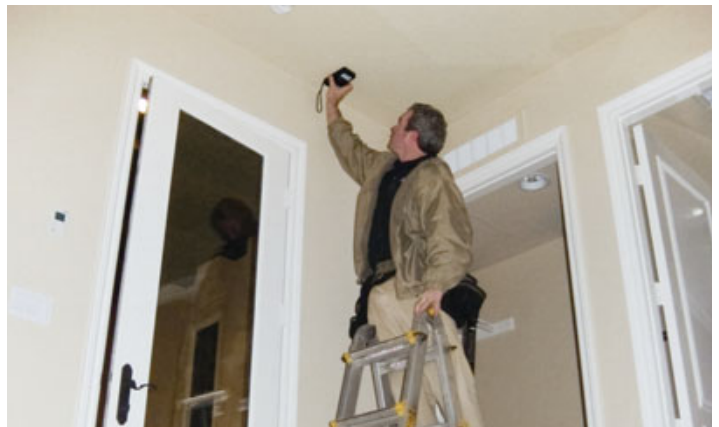
During an energy survey of a new home, the author's IR camera recorded this image (top) showing spots in the ceiling that were not visible on the drywall (above), and which did not look like voids in the insulation. A hand-held moisture meter confirmed the presence of moisture (right); the culprit was a leaky roof flashing.

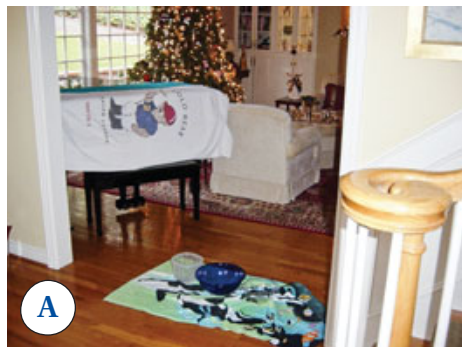
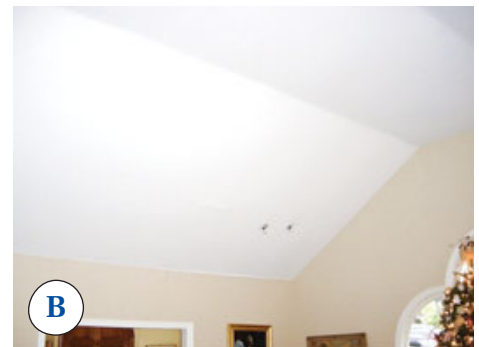
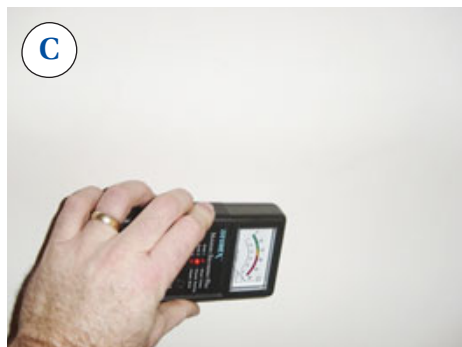
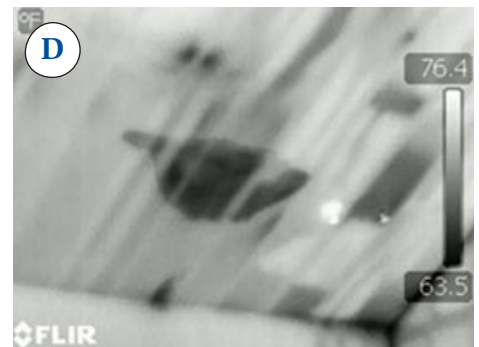
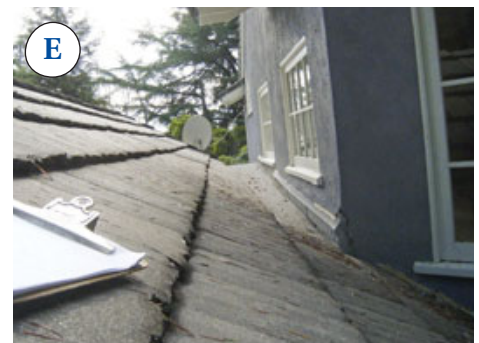
In this case, the homeowner had already replaced the roof three times, seeking to cure an ongoing leak. The roofing contractor was now insisting that replacing an upper section of the roofing would fix the leak, but the owner wanted to try our services first. When we arrived, we found the usual assortment of buckets on the floor (A). After talking to the owner about the problem, we turned on our camera and went to work. Though you may not be able to see it in the photograph (B), there was a slight bulge in the drywall ceiling but no other signs of moisture. The moisture meter, however, read off the scale when placed on this spot (C), and an IR image (D) showed a concentration of moisture. (Note also the dark square areas to the right of the moisture spot; these indicate voids in the cathedral ceiling's insulation.)

The root of the problem turned out to be poor roof design (E). In heavy rains, water from an upper roof cascaded onto the lower steep-slope roof, where it was directed back against the building and in around the poorly executed counterflashing on the wall, eventually finding its way into the living room ceiling. Our recommendation was to install a new wide cricket flashing, taller counterflashing, and gutters on the upper roof to redirect the bulk of the water.

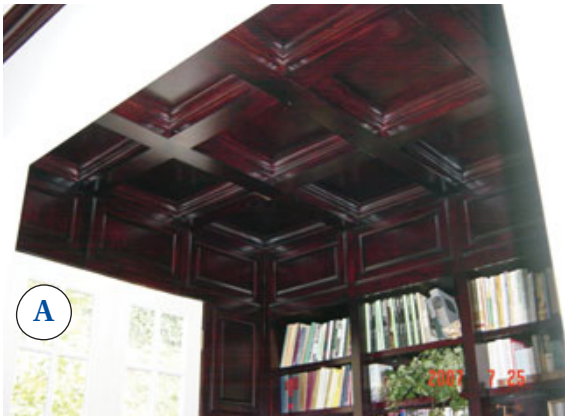
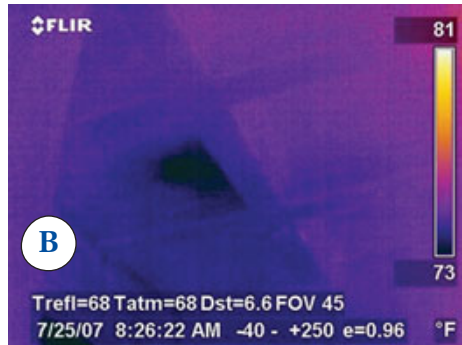
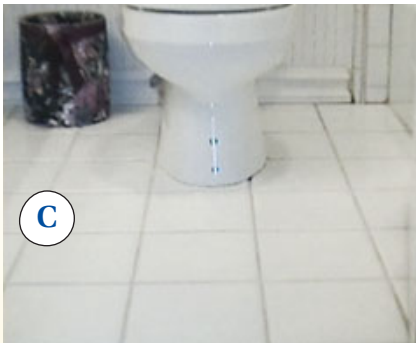
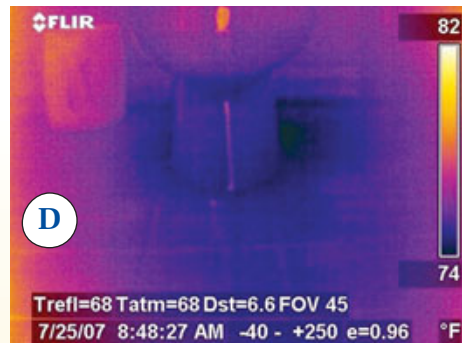
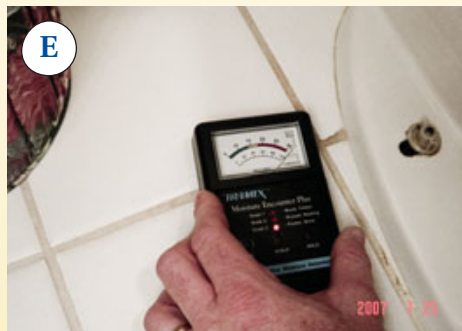
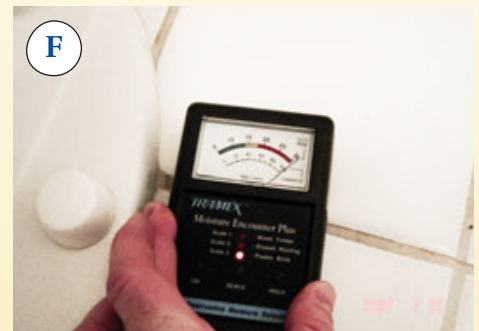
For seven years, the homeowner had tried various repairs to fix a leak that showed up in his library ceiling (A). The bathroom above seemed the obvious source, even though it was never used. One contractor had opened up the drywall around the tub and replaced all the plumbing, but that didn't stop the leak. Another contractor replaced the angle stops on the fixtures, but — again — to no avail. The owner began to suspect the bathroom window and called me in to set up my spray apparatus and do some water testing. But first, we pulled out the camera.

The dark spot in the infrared scan of the ceiling (B) helped to pinpoint the source of the water. Upstairs, we found that this coincided with the location of the toilet (C). As you can see in the thermal image (D), there's a darker area on right side of the toilet. A moisture meter confirmed that the floor around the toilet was soaked (E, F). We made some measurements downstairs and found that the wet spot in the office was 55 inches from the outside wall — the same distance as the right-hand toilet bolt.

In questioning the owner about use of the bathroom, we learned that in fact the house cleaner flushed this toilet as part of her weekly cleaning — a seven-year mystery solved.

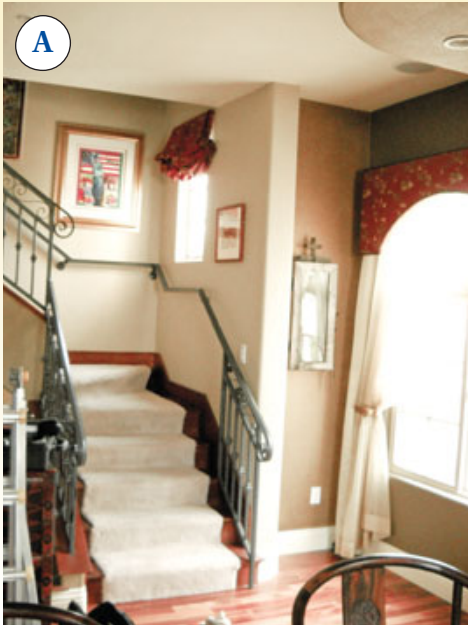
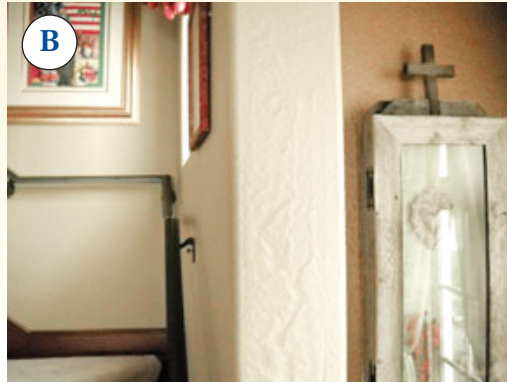
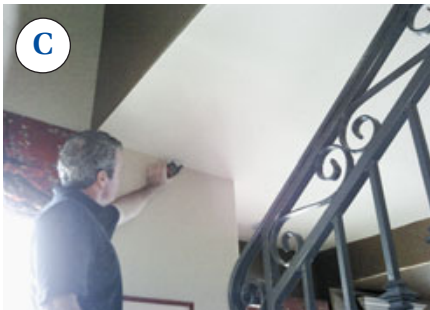
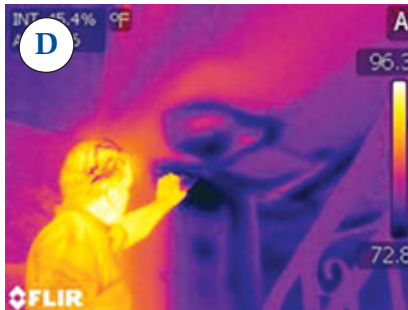
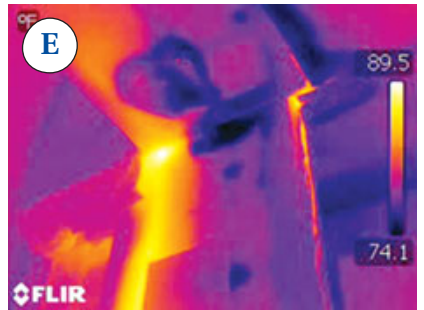
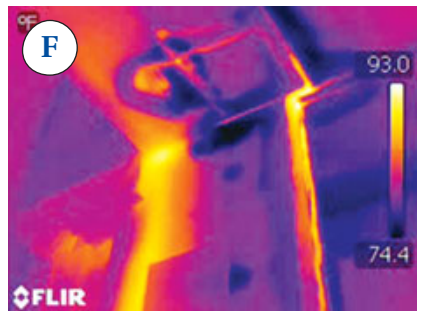
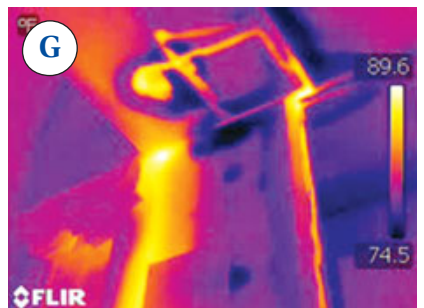
A general contractor called, saying he believed he had a roof leak in a house he had built and asking me to take a look. I found a patch of blistered paint on the return wall of the home's main staircase (A, B). Moisture readings confirmed that the wallboard in the area was damp (C). A bathroom upstairs might have been the likely culprit, but the builder had already repaired leaky supply pipes a few months earlier, so now he suspected the roof. However, the initial IR scan (D) showed a pattern of water under the bathtub, so we figured we'd start there.

We turned on the hot water and let it run, then set the camera on time-lapse mode and began scanning. In a couple of minutes, the water began to show up as a bright yellow streak coming down the corner of the wall (E). (You can also see the hot-water supply pipe running up through the wall to the left.) Then gradually, as the wall was saturated, the hot water filled in beneath the tub (F, G), which turned out to be the source of the leak.

As this case illustrates, the moisture stain is often in a different location than the leak, because water will always follow the path of least resistance. The great advantage of the infrared image is that it shows the path, right back to the source.

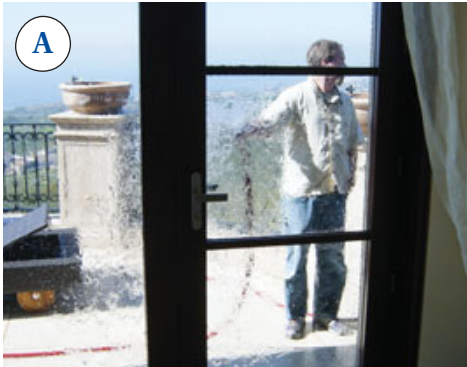
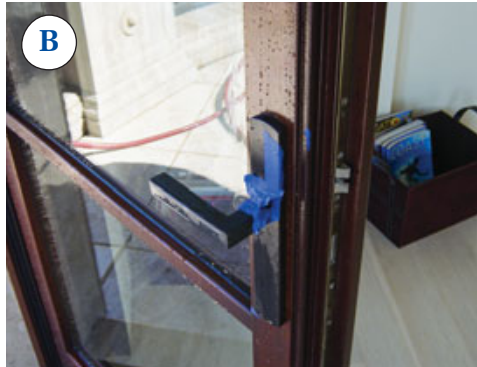
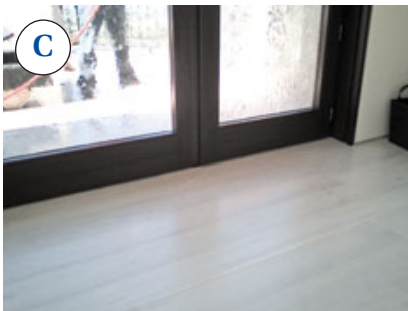
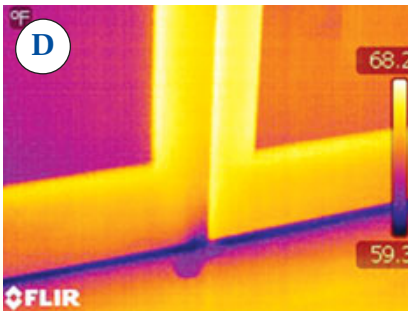
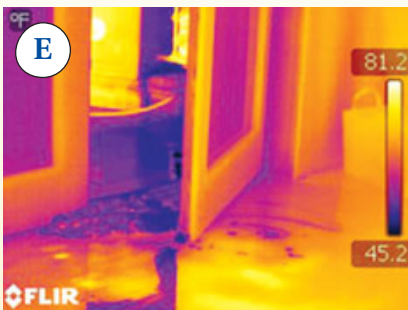
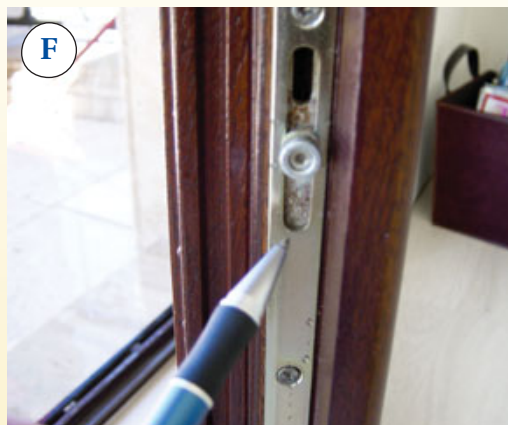
After getting up to speed on what had been done, we used a hose to perform a water test (A), which would help us figure out where the water was getting in. We taped off obvious points of entry, like the keyhole (B), to rule those out. Before long, water was coming in under the door, as both the visual and infrared photos show (C, D). When we opened the door, the IR scanner quickly picked up something that might not have been obvious — the water was flowing out from inside the bottom corner of the door (E). The problem wasn't the caulking or weatherstripping, but

simply a small gap between the door handle and the faceplate, which allowed water to enter and run down through the three-point locking mechanism. Note the rust spot on the hardware (F) where the water came in. We recommended adding a rubber washer between the handle and the plate — an inexpensive fix, considering how much money had been invested in trying to solve the problem.

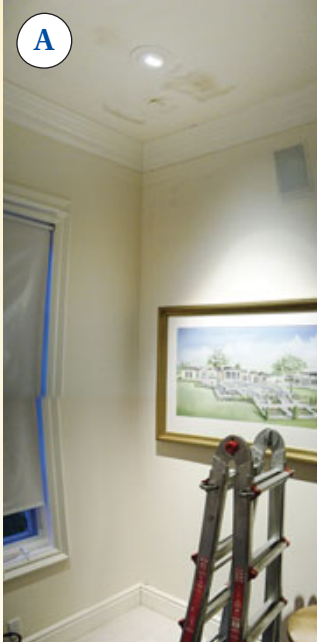
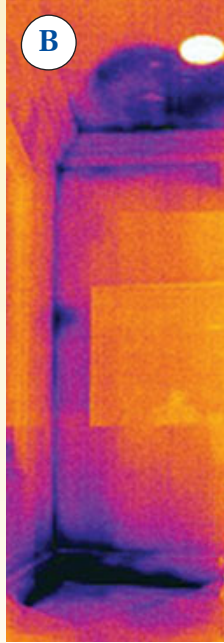
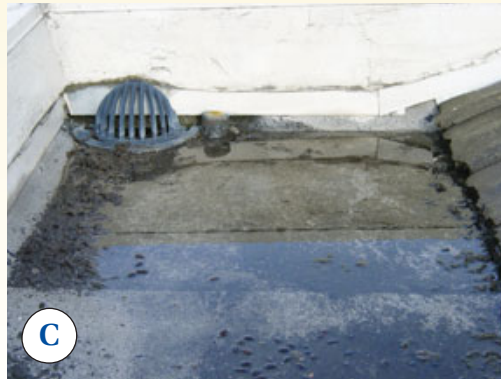
As you can see from the visual image (A), there was some moisture damage on the ceiling, but it seemed to be limited to that one location. But in the thermal image (B), it's obvious from the darker areas that the water had in fact traveled all the way to the floor. When we went up on the roof, we found that ponding was occurring because an overflow drain at the parapet wall was improperly installed (C). This was a leak waiting to happen.

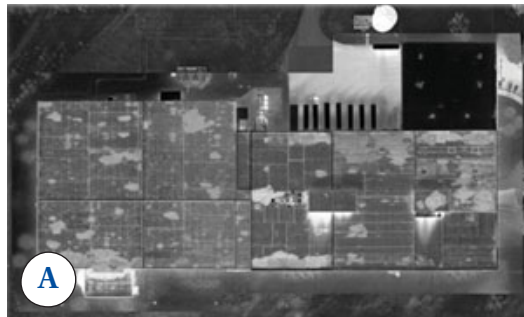
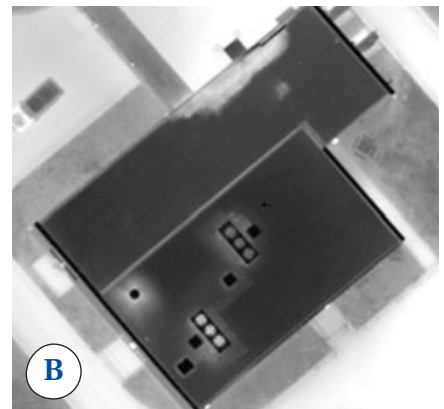
The white lines in this scan of a large low-slope roof (A) indicate moisture trapped along the edges of the rigid insulation panels. The other light-colored irregularly shaped areas show places where the insulation is wet. In the image of a flat roof (B), the light-colored area at the top indicates moisture in the roof substrate.
