Techniques for Finding and Documenting Moisture Intrusion in Buildings with an Infrared Imager

by: R.W. Olsen & Greg Stockton

Abstract

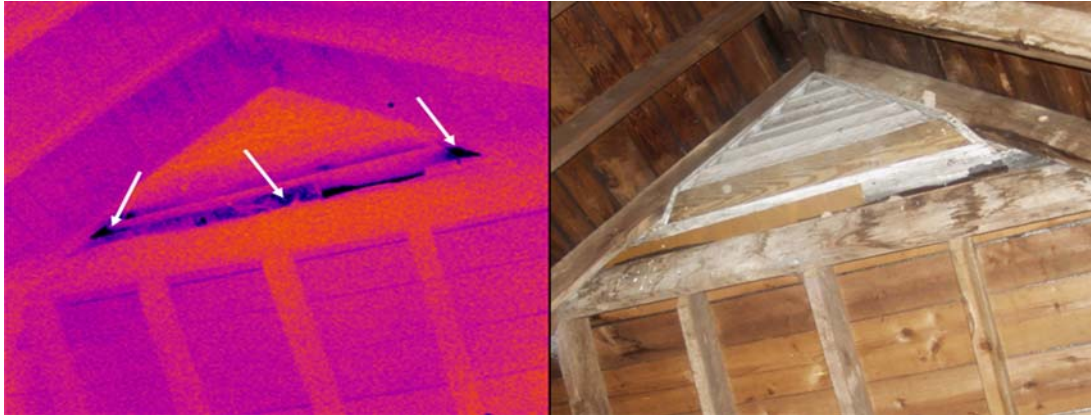
Figure 1 – Water entering the attic of a large church at the gable end vent.

Water can leak into a building from the roof or skylights in the roof. A roof leak over an accessible attic space makes for some very easy detective work during a regular rain even. A flashlight is normally all that one needs to ascertain where the leak started and where it's going. If the manufactured skylight component itself can be eliminated as a source of water intrusion, then the likely cause would be inadequate or improper flashing of the unit to the roof. Water leaking at the roof-to-chimney juncture or any other place such as venting, is usually easily found visually and even more easily found with an IR imager (See Figure 1). A combination roof/ceiling assembly created using scissors trusses proves to be one of the most difficult investigations to accomplish due to lack of access.

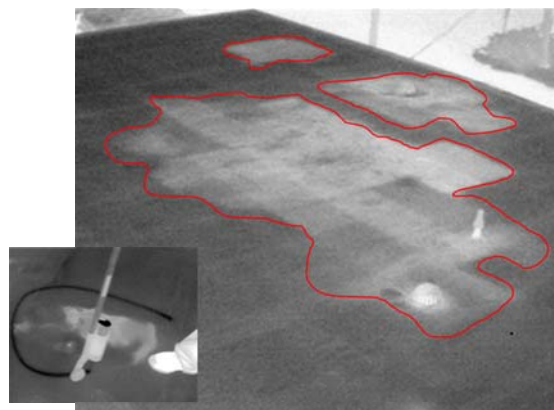
Figure 2 – On-roof moisture survey on an apartment building roof.

In buildings with flat or low-sloped roofs, water can enter the substrate through a breach in the waterproofing layer and be absorbed to the point where water enters the building from above. An infrared survey will often reveal the extent of the moisture contamination from above the roof so that surgical roof repairs can be made (See Figure 2).

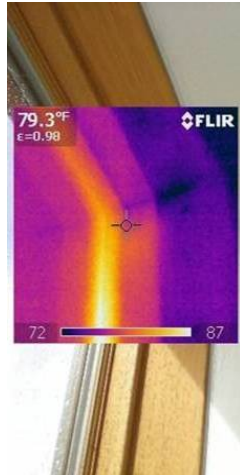
Figure 3a – Water intrusion at a window.

The very best time to perform an infrared thermographic inspection is when the leak first presents. An infrared image documents the reality of the situation (See Figures 3a/3b) and is the basis from where the investigation should go from there. With the proper information from the infrared inspection in hand, a builder may elect to remove interior finishes from around the window or door if a thermograph shows water not under a window - but off to the side of it. The same holds true for a door unit. An infrared thermograph offers a way to document water intrusion and may indicate that the leakage is under the doorsill for instance, which the builder must then correct himself.

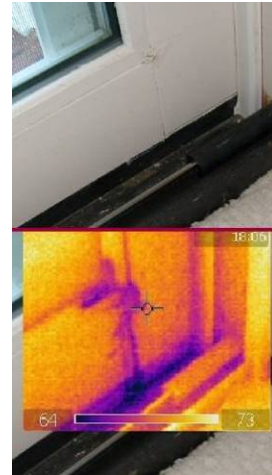
Figure 3b – Water intrusion at a door.

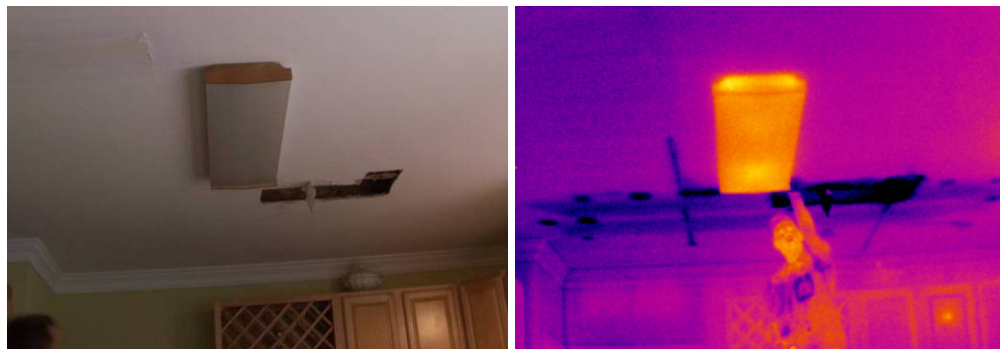
Figure 4 – Plumbing fixture leak in a house, found in seconds with an infrared imager.

When plumbing pipes, (See Figure 4), water lines, sprinkler lines or mechanical lines within the structure leak, the damage can be devastating. Often by the time the water leak is detected, much damage has already occurred. A broken plumbing pipe that goes unchecked for minutes, hours or in some cases, days, it can cause horrific damage not only to the interior, but also to the structure of a building itself. Some problems caused by condensation on mechanical lines in an attic or within walls such as low pressure return lines or a condensation evacuation line for an air conditioning unit can be quite insidious. These failures can contribute to a hidden growth of large colonies of mold. Infrared thermography is particularly good at tracking down active leaks of almost any kind.

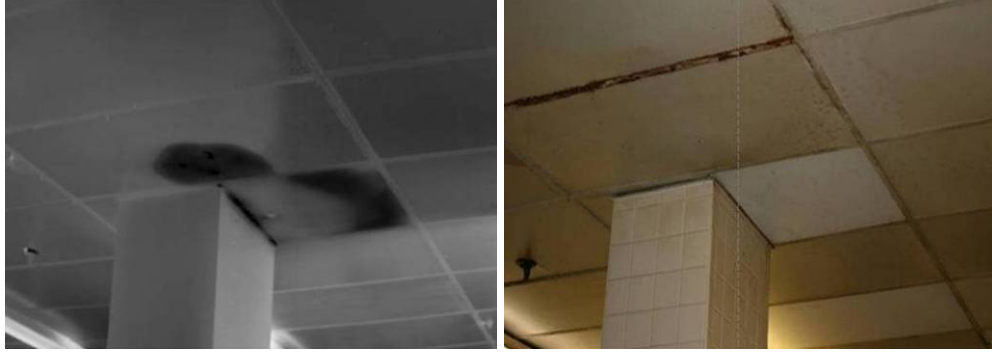
Figure 5 – Uninsulated column passing from cool area into the warm, moist interstitial space, causing condensation on the column, which then drips onto the ceiling tiles.

Sometimes moisture envelope problems are characterized by heat loss and by moisture that forms on the building surfaces where warm, moist air meets cool surfaces or vice-versa. This can happen on the surfaces of windows, doors, skylights, HVAC equipment, outside walls, interior walls, wall assembly interiors and ceilings as a result of air leakage, thermal bridging, improper ventilation, design flaws and/or installation deficiencies. At the dew point, moisture forms and drips into the building (See Figure 5).

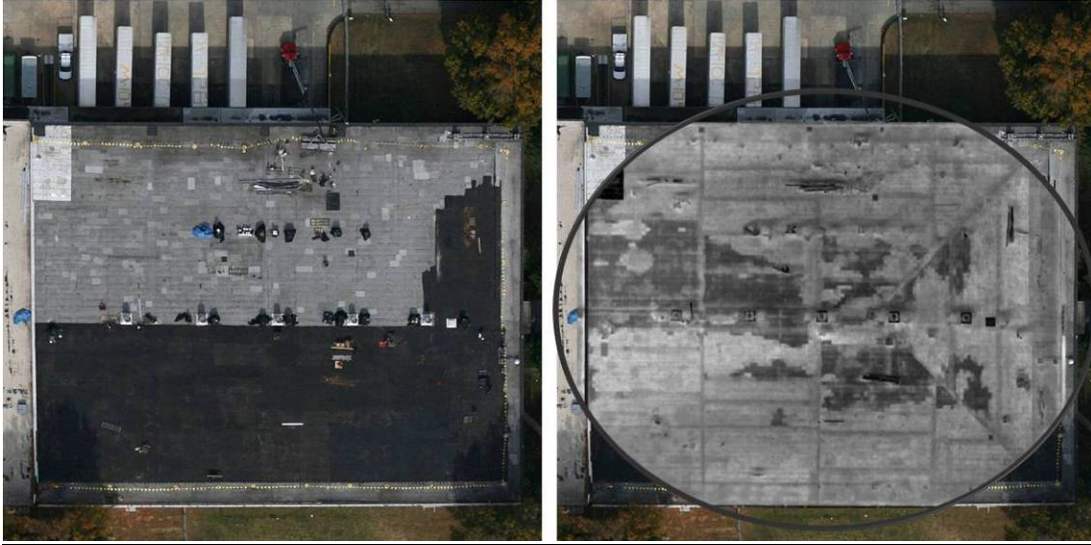
Figure 6 – Flat roof with wet insulation (lighter gray) being covered with new coatings.

If a new basement does not dry out completely or is flooded during construction, this can have an adverse effect on every building process that takes place above. The longer that a building component takes to dry, the more irreversible damage is done. Detection and mitigation of water intrusion throughout the entire building process is critical. There is no better or faster way to ensure that the building process remains true than the active use of infrared thermography to detect and document the presence of moisture (See Figure 6).

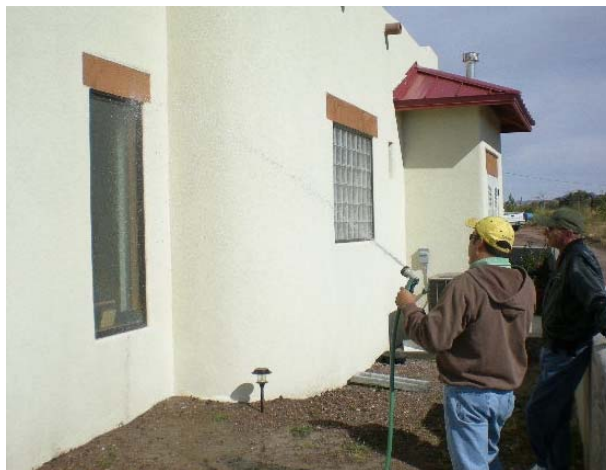
Figure 7 – Non-calibrated hose test being performed.

Even among experienced professionals the type of testing most frequently used is a garden hose with an adjustable nozzle, operated in a manner dictated by the immediate objective of producing or replicating a leak (See Figure 7). The water pressure, spray pattern, distance from target, angle of attack, and time of exposure are determined in the field to suit local conditions. While this may be effective as a diagnostic exercise, it has the disadvantage of potential criticism for a lack of objectivity. This type of testing produces results that do not replicate expected environmental conditions. An example of which would be the production of a test leak by pointing a nozzle up at a void under a soffit that would never be subjected to a wind-blown rain.

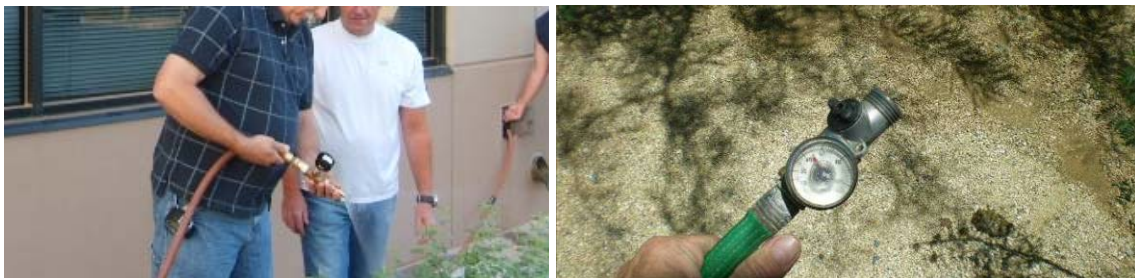
Figure 8a/8b – Calibrated hose test in the simplest form.

To counter criticism involving objectivity, as well as to provide reliable results, test procedures sanctioned by established industry associations and standards organizations are available and recommended. Relatively simple and inexpensive is the *American Architectural Manufacturers Association (AAMA) 501.2, Field Check of Metal Storefronts, Curtain Walls, and Sloped Glazing Systems for Water Leakage*. This test method is used for exterior windows, curtain walls, storefronts, sloped glazing systems, doors, and other wall components, and is similar in concept to the simple garden hose spray method. It is most effective for joints that are designed to be permanently closed or watertight. Often referred to or described as the Hose Test Method, it involves the use of a *calibrated* hose nozzle only (See Figure 8a/8b) to deliver water to the test specimen at prescribed pressures. The test procedure consists of systematically wetting the test specimen with water from the spray nozzle that is held at a distance of at least 12 inches from the joint. The nozzle is moved slowly back and forth along the non-operable joint covering approximately 5 linear feet of joint during a 5-minute period. This test is not intended for residential use.

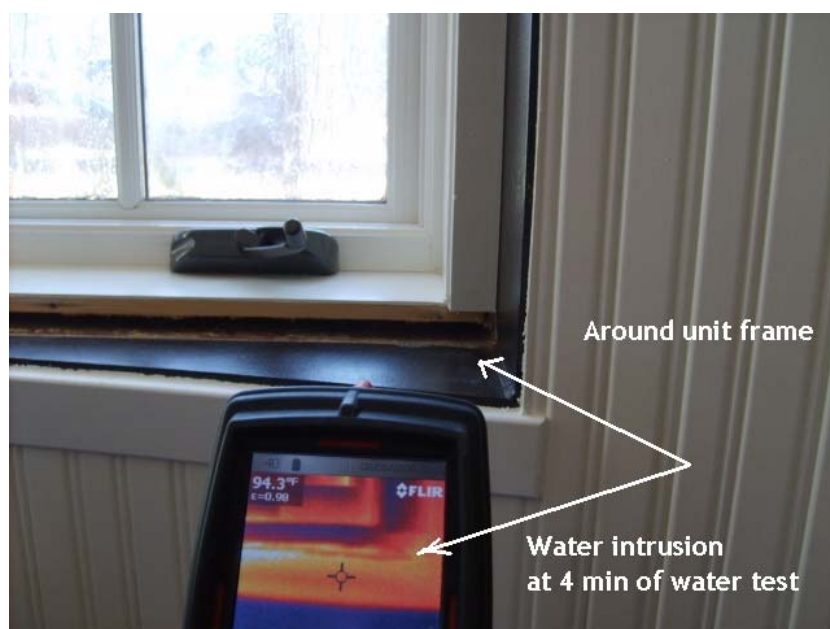
Figure 9 – Infrared imager documents water intrusion.

Infrared thermography on the other hand, is not nearly as restricted to color, gloss or lighting conditions on an interior building finish. An infrared thermograph (See Figure 9) is a digital record of the moisture as it intrudes and can often document the path and progress of water intrusion.

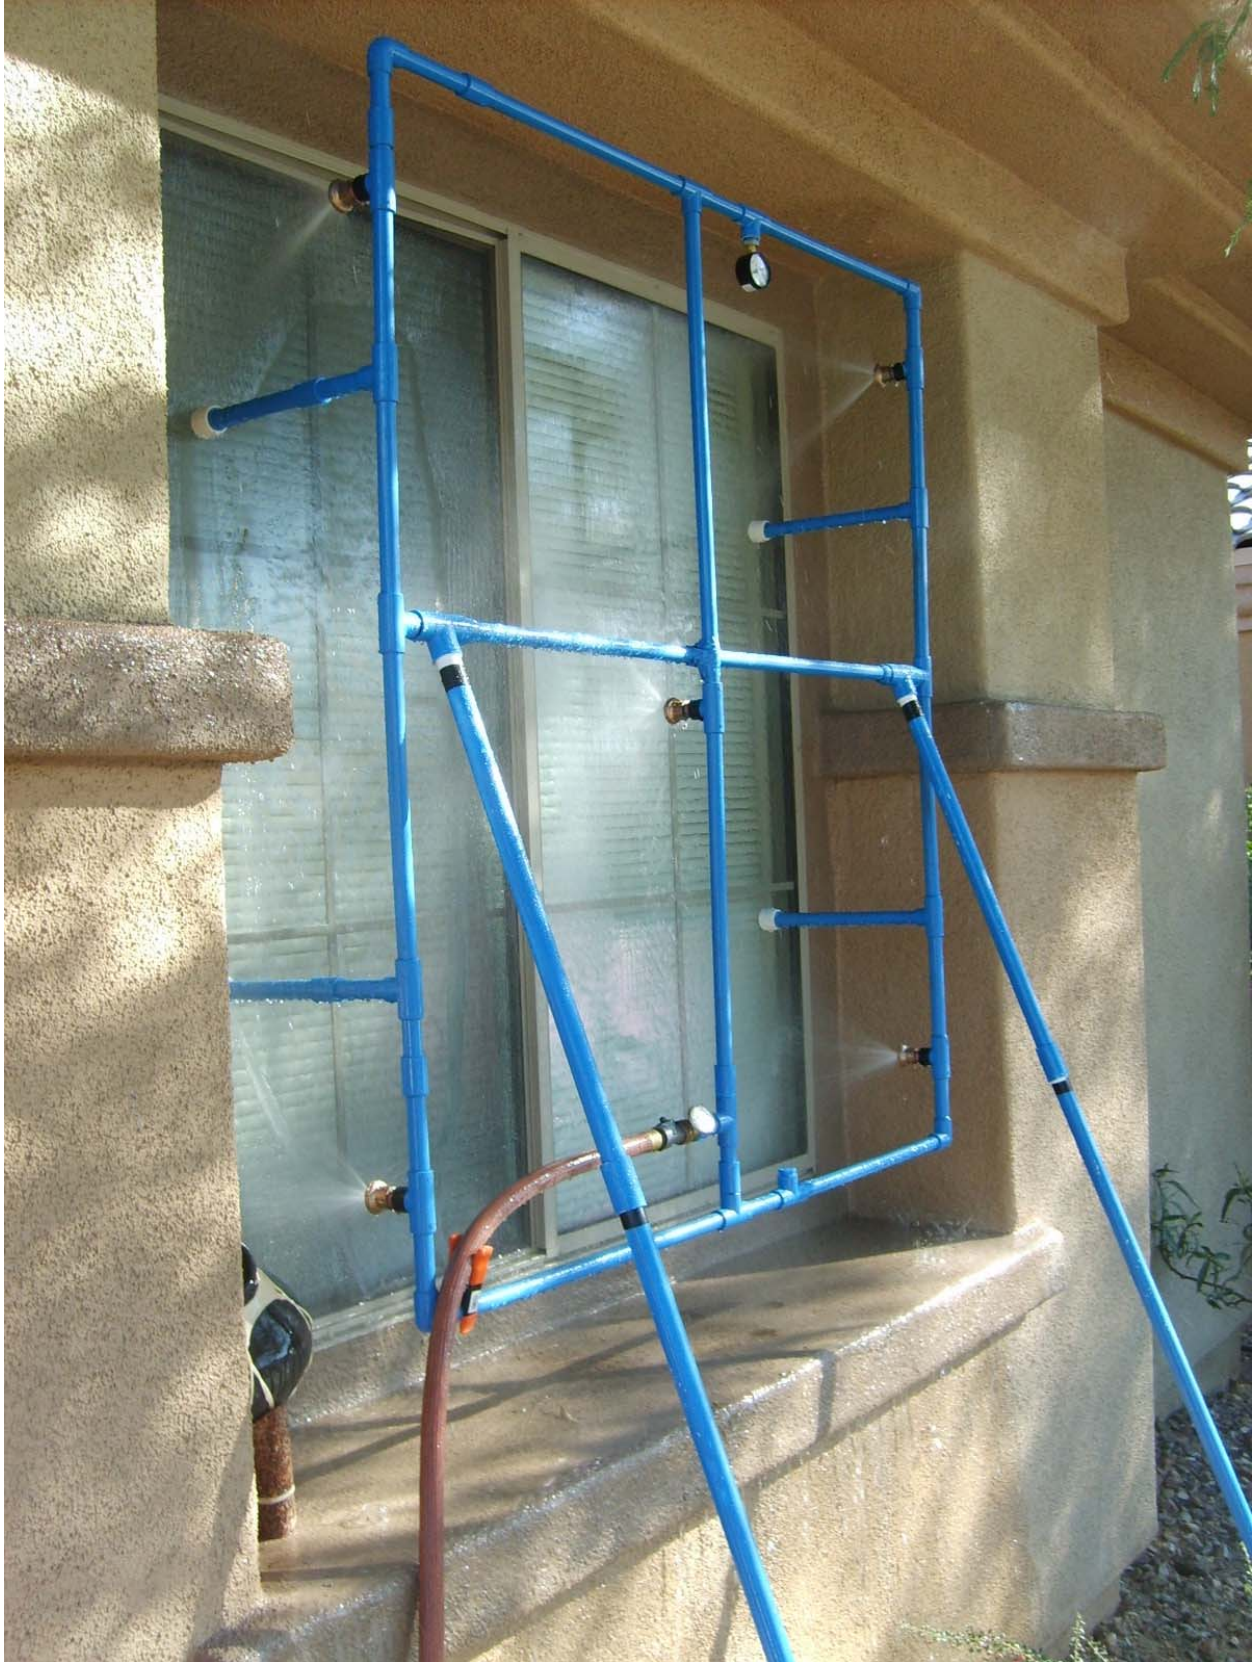
Figure 9 – Calibrated spray rack set-up.

A more sophisticated and expensive test is described in *ASTM E-1105-00, Field Determination of Water Penetration of Installed Exterior Windows, Curtain Walls and Doors by Uniform or Cyclic Static Air Pressure Difference*. This method is useful for determining the in-place performance of a specimen when subjected to a prescribed rate of wetting under a defined static pressure difference.

This method is often referred to as the Chamber Test Method, or differential pressure method, because it specifies that a test chamber be installed either on the exterior or interior side of the test area. The test procedure consists of delivering water to the exterior from a calibrated spray rack at a minimum rate of 5gal/ft²/hr*, while simultaneously applying a specified differential pressure across the specimen. The test can be performed for durations of 15 minutes of static pressure or in a cyclic procedure in which the differential pressure is applied for 5-minute durations, with 1-minute interruptions of no differential pressure and only water spray.
