What to look for first, when performing infrared building surveys

By: Gregory R. Stockton
Stockton Infrared Thermographic Services, Inc.
8472 Adams Farm Road
Randleman, NC 27317-7331
(800) 248-7226
www.StocktonInfrared.com
greg@stocktoninfrared.com

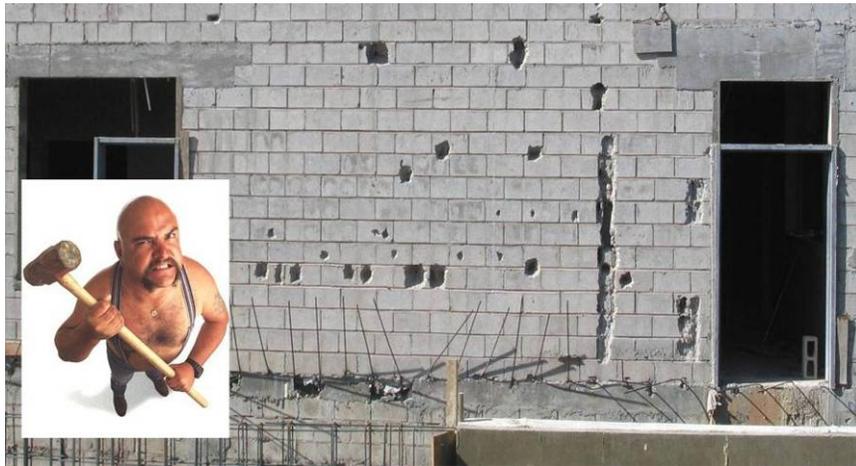
Figure 1. Photo of a CMU wall undergoing destructive testing.

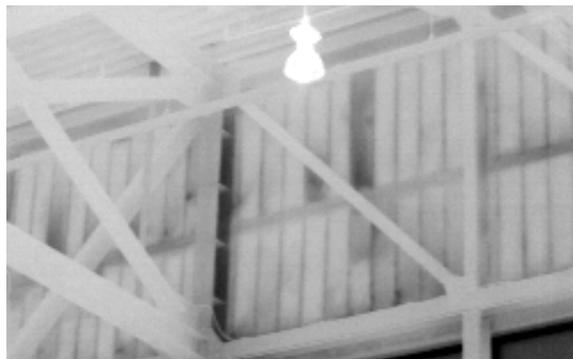
Figure 2. Infrared image of a convention center wall with missing and misplaced fiberglass batt insulation (darker areas).

Thermal and moisture problems in buildings are sometimes interrelated. For instance, entrained water in an insulated flat roof is obviously a moisture problem, but the wet insulation increases the conductance of heat, therefore it is also a thermal problem. Thermal envelope problems (see Figures 2 - 10) are characterized by heat loss and sometimes by moisture that forms on the building surfaces where warm, moist air meets cool surfaces. At the dew point, moisture forms and then the water drips into the building. This can happen on the surfaces of air conditioning equipment, outside walls and inside walls and ceilings as a result of air leakage, or thermal bridging from misplaced, incomplete, wet and/or missing thermal insulation, improper ventilation and/or design flaws. Since the air conditioning ducts are usually installed above the ceilings, moisture can form on the ductwork and drip onto the ceilings, if it not properly designed, installed, insulated or if leaking.

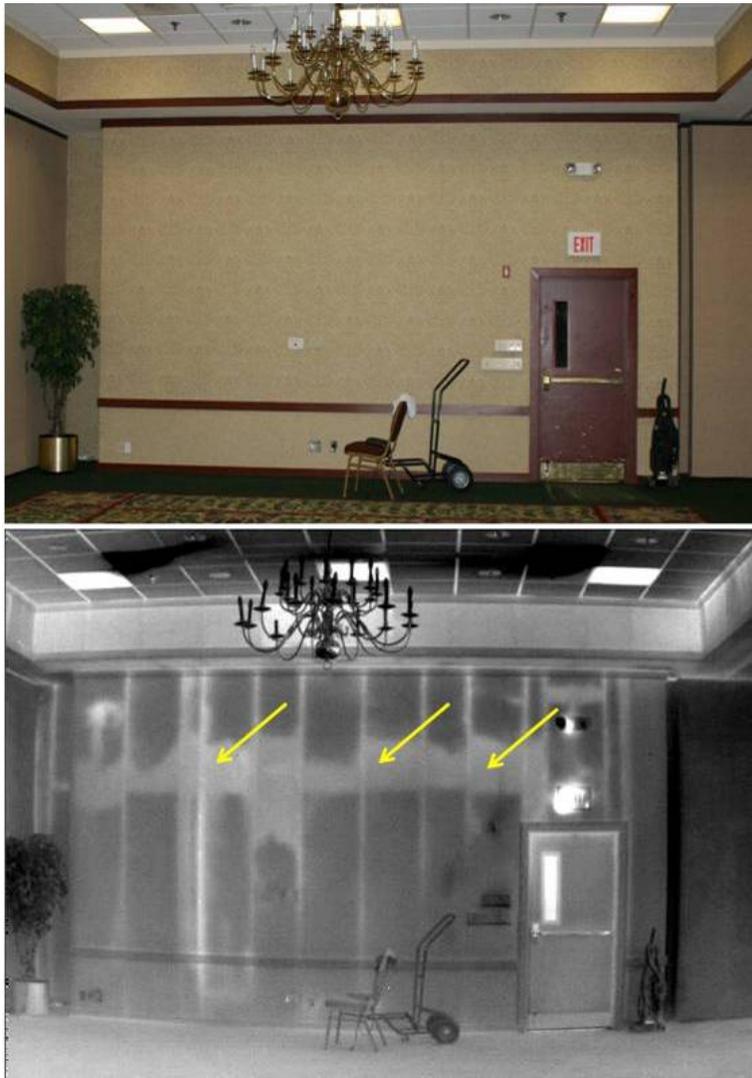
Figure 3. Visual and infrared image of a hotel wall with missing and misplaced fiberglass batt insulation (lighter areas).

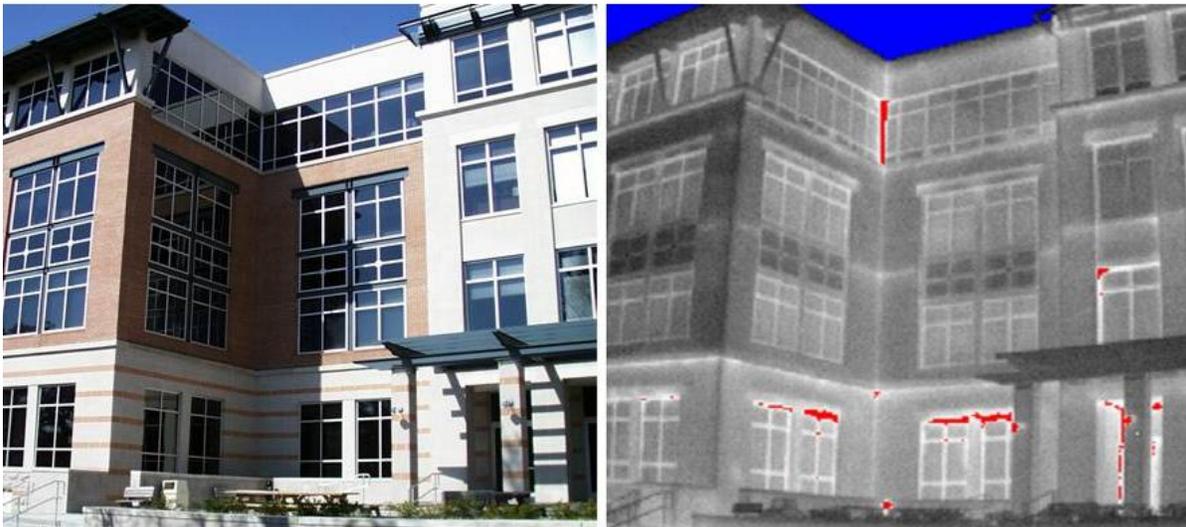
Figure 4. Visual and infrared image of an office building showing air leakage.

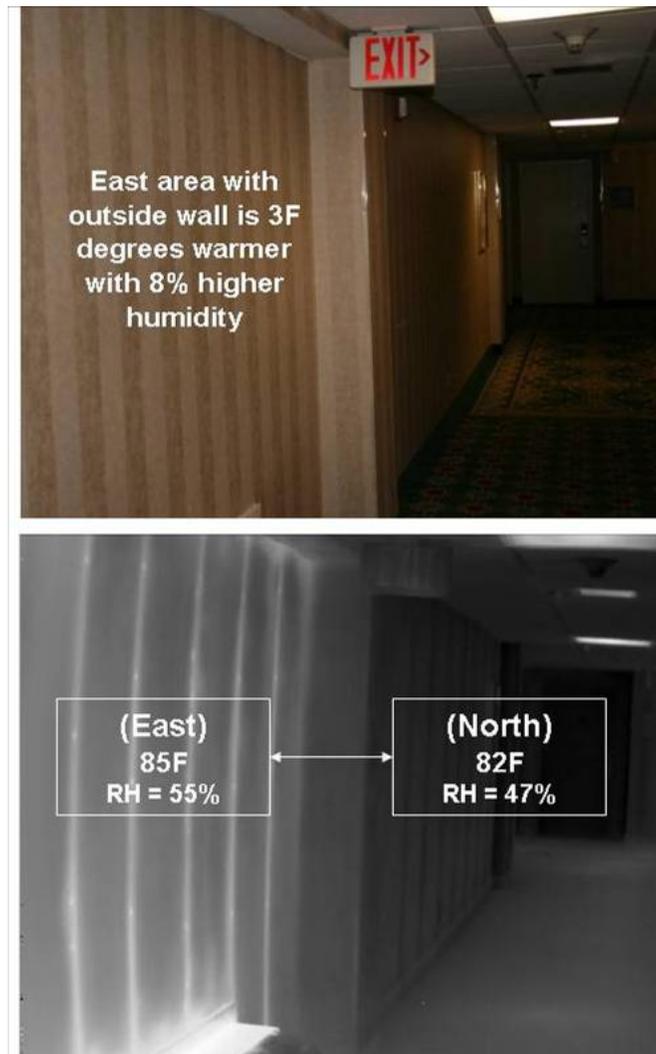
Figure 5. Visual and infrared image of a library hallway showing imbalanced air flow, temperature and humidity.

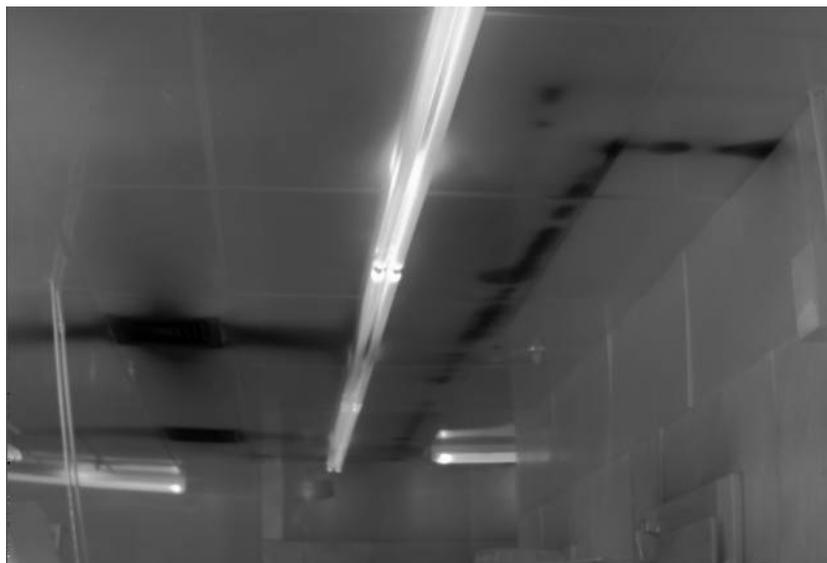
Figure 6. Infrared image of a restaurant kitchen, where uninsulated cold piping in the warm interstitial space drips water onto the ceiling.

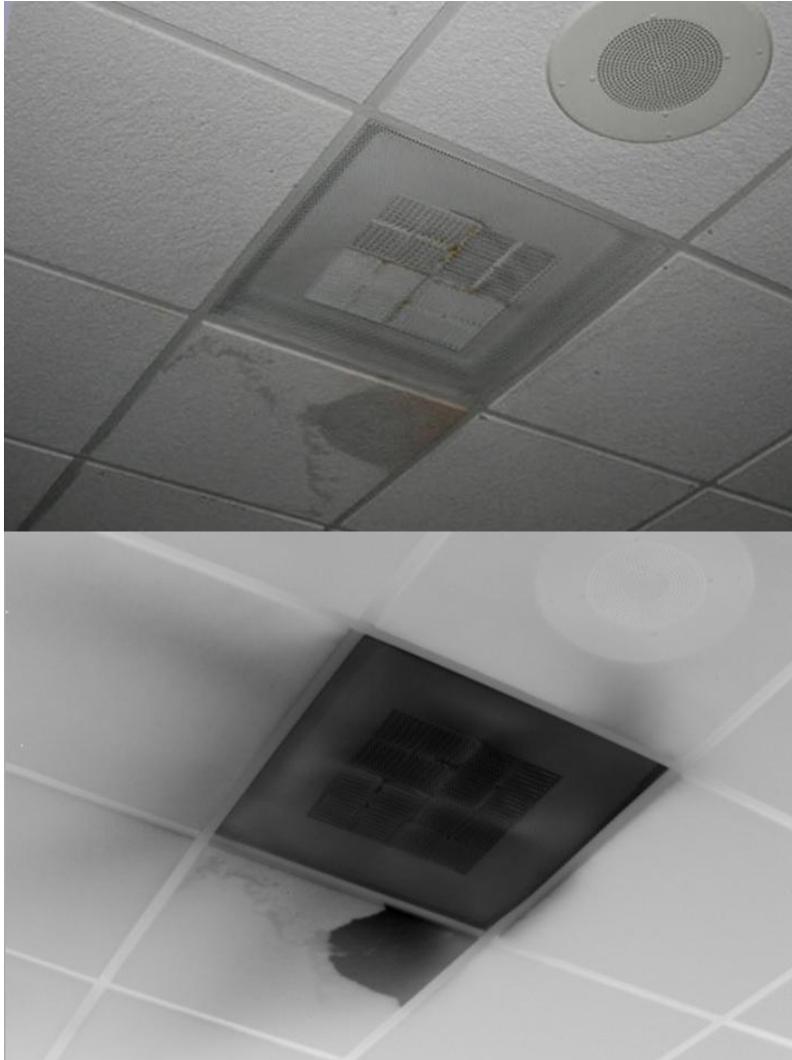
Figure 7. Often, ductwork is not sealed well or not fastened tight to the diffusers, which allows cool air to blow into the warmer interstitial space creating condensation that drips onto the acoustical ceiling tiles.

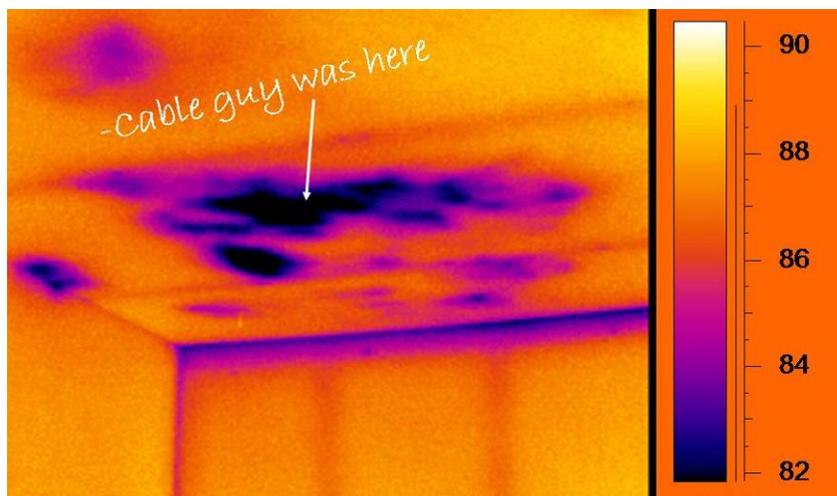
Figure 8. Infrared image of the ceiling of a house showing disturbed insulation.

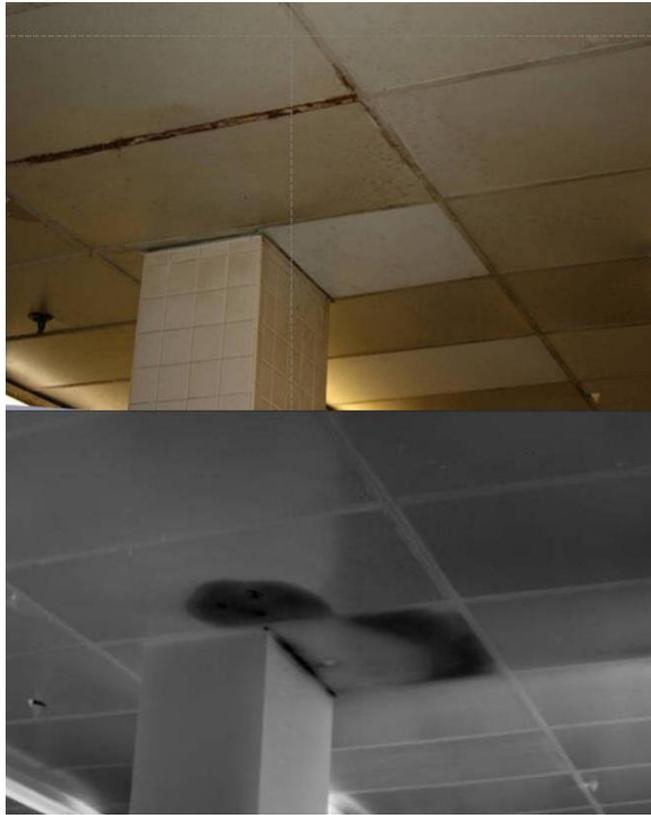
Figure 9. Uninsulated structural components such as a column may pass from a cool area into the interstitial space causing condensation on the column which drips onto the ceiling.

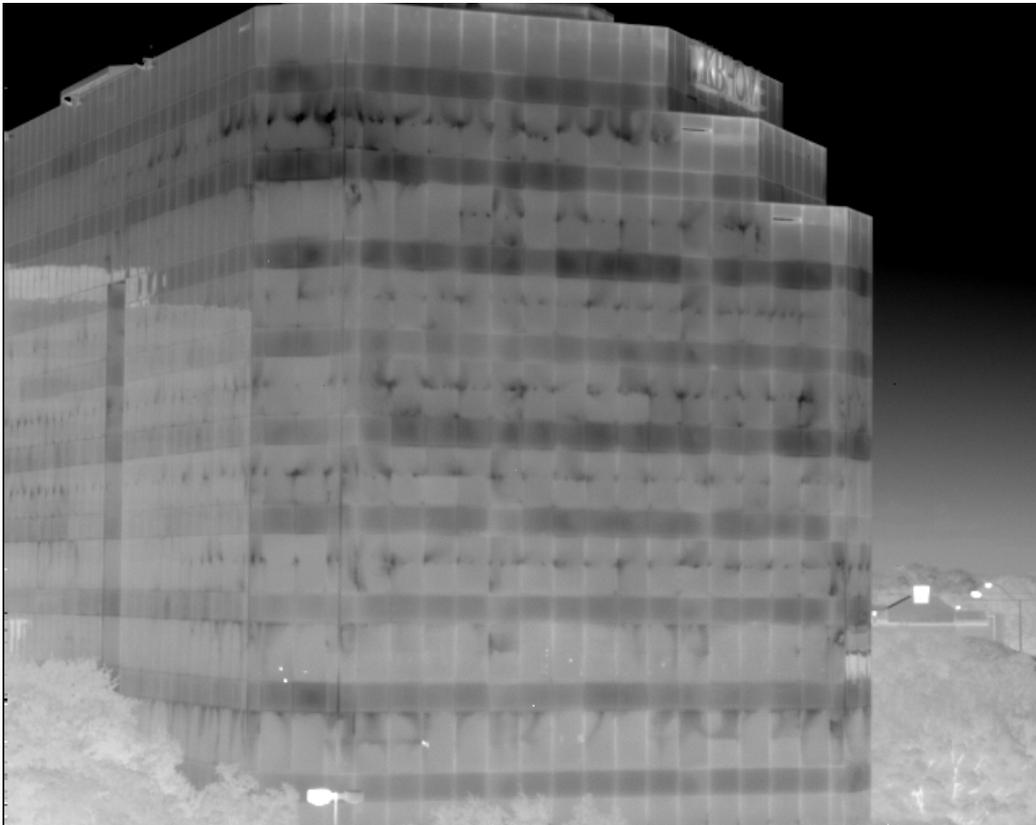
Figure 10. Infrared image of an office building showing many air leaks.

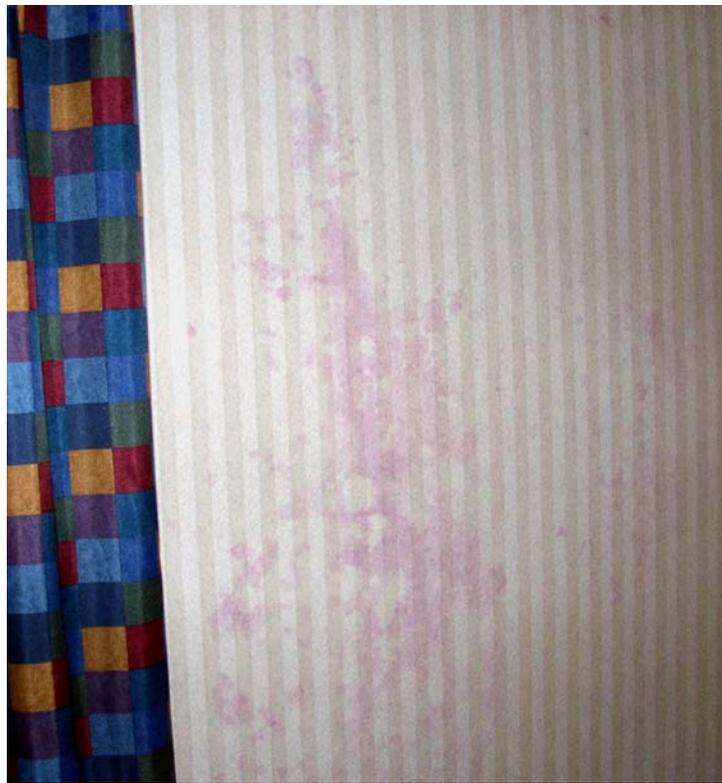
Figure 11. Visual image of the inside of a hotel outside wall with non-perforated vinyl wallpaper showing stains from mold.

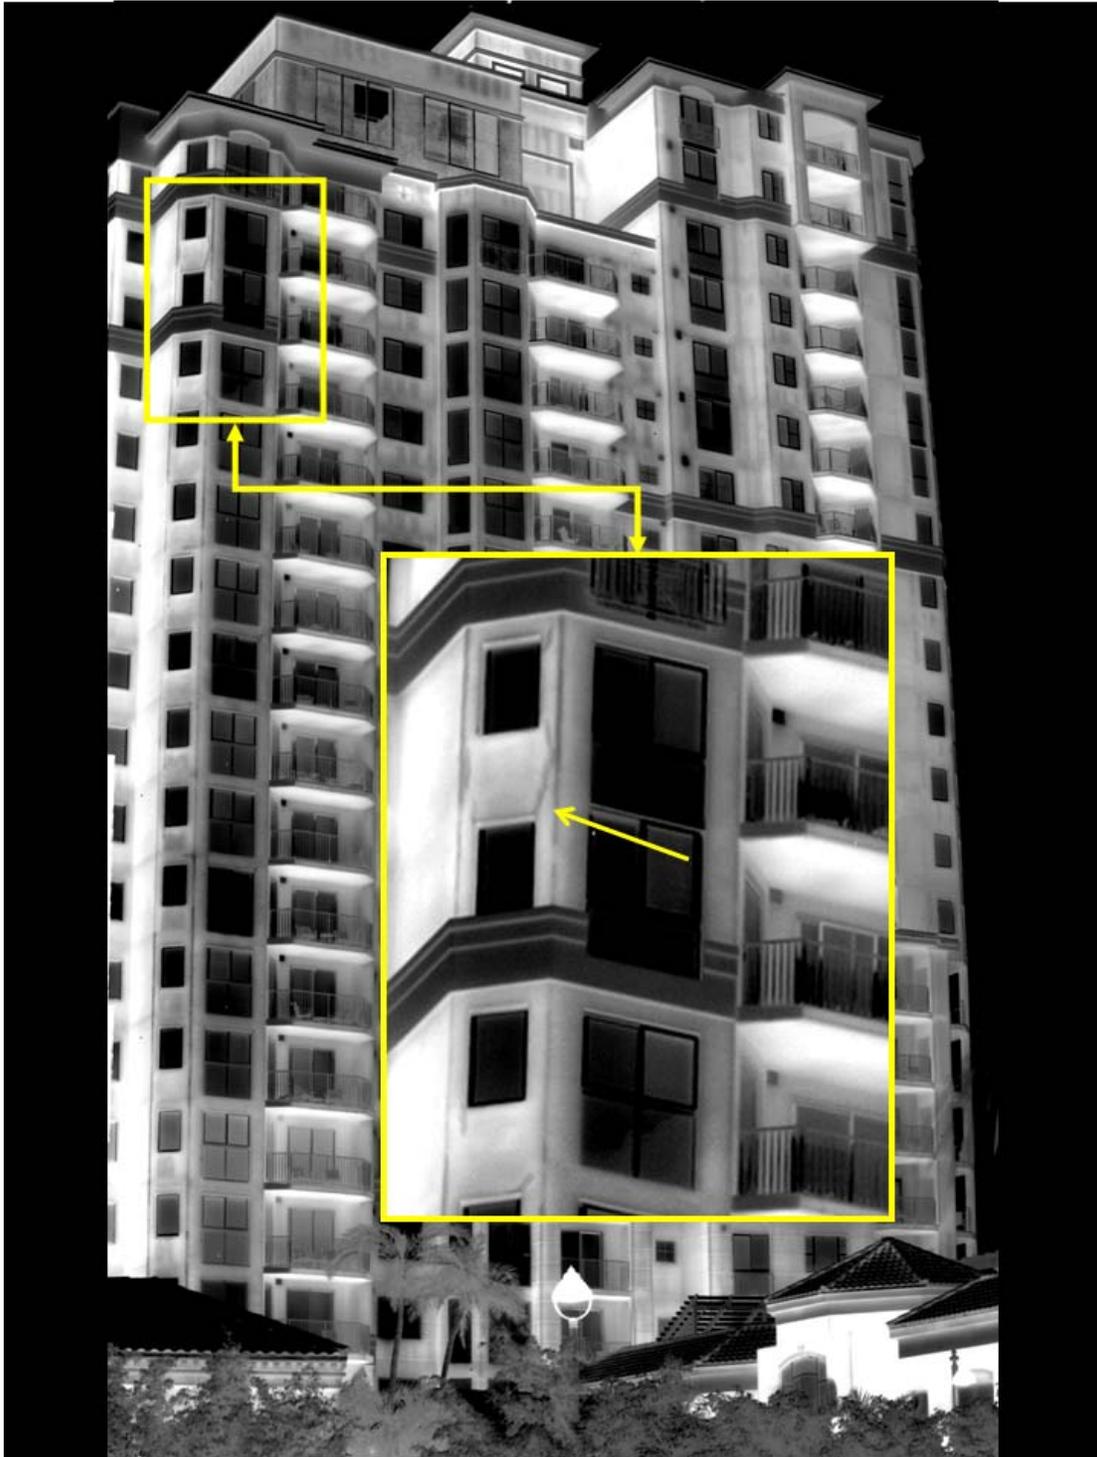
Figure 12. Infrared images of a new condominium with stucco delamination shown.

Stucco is an exterior plaster or interior plasterwork applied directly to the framed structure of a building. There are two types of stucco; cement and synthetic. Cement stucco has been used for thousands of years. It is a mixture of Portland cement, sand and lime. Synthetic stucco or EIFS (exterior insulation and finish system) is a combination of foam board insulation and several coats of acrylic polymers. Because both types of stucco are layered onto a building, there is a possibility that the layers will delaminate from one another and/or from the building. During transient thermal conditions, the walls will show delaminations (see Figure 11) because the delaminations are insulated from the solid wall and therefore change thermally at different rates.

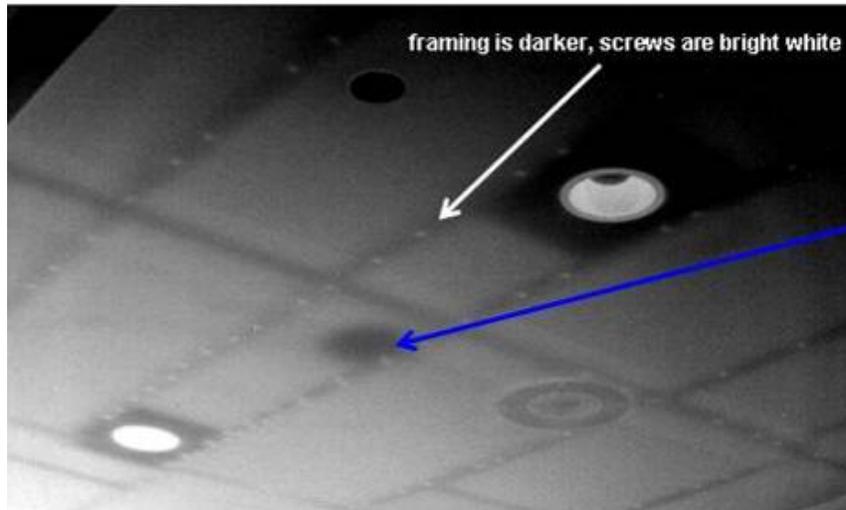
Figure 13. Structural components such as wood, metal framing and the fasteners can be seen with the use of thermal imaging. The blue arrow is pointing at a moist spot.

As shown in the example below (Figure 13, 14), the structural components of a building can often be seen while the building undergoes thermal transitions.

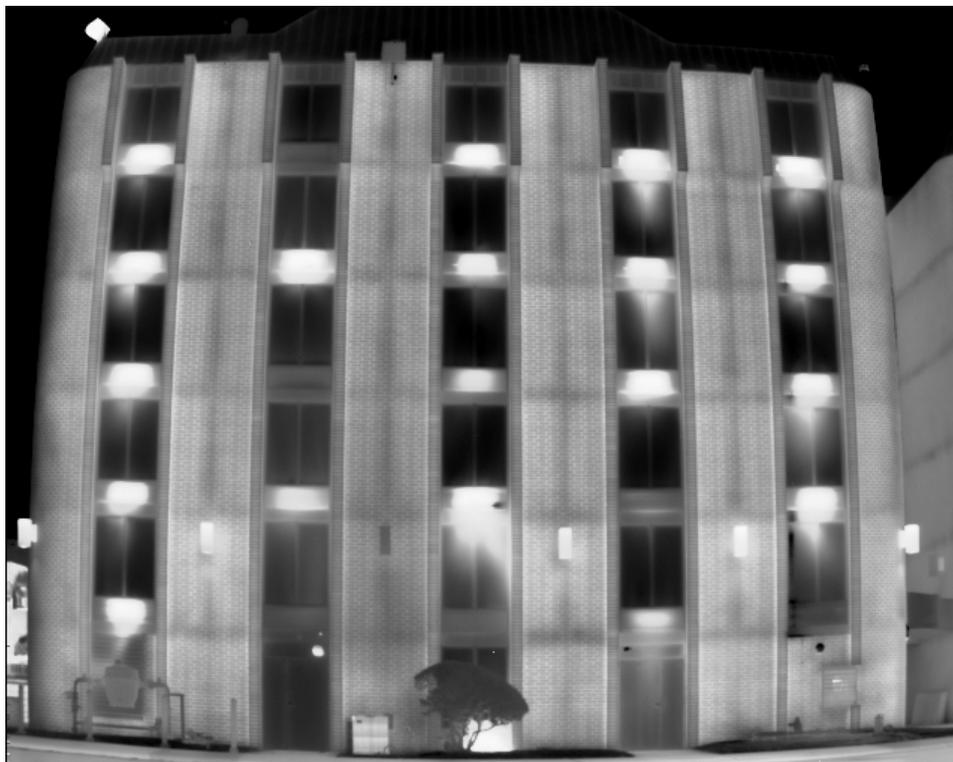
Figure 14. Structural components such as concrete framing can also be seen.

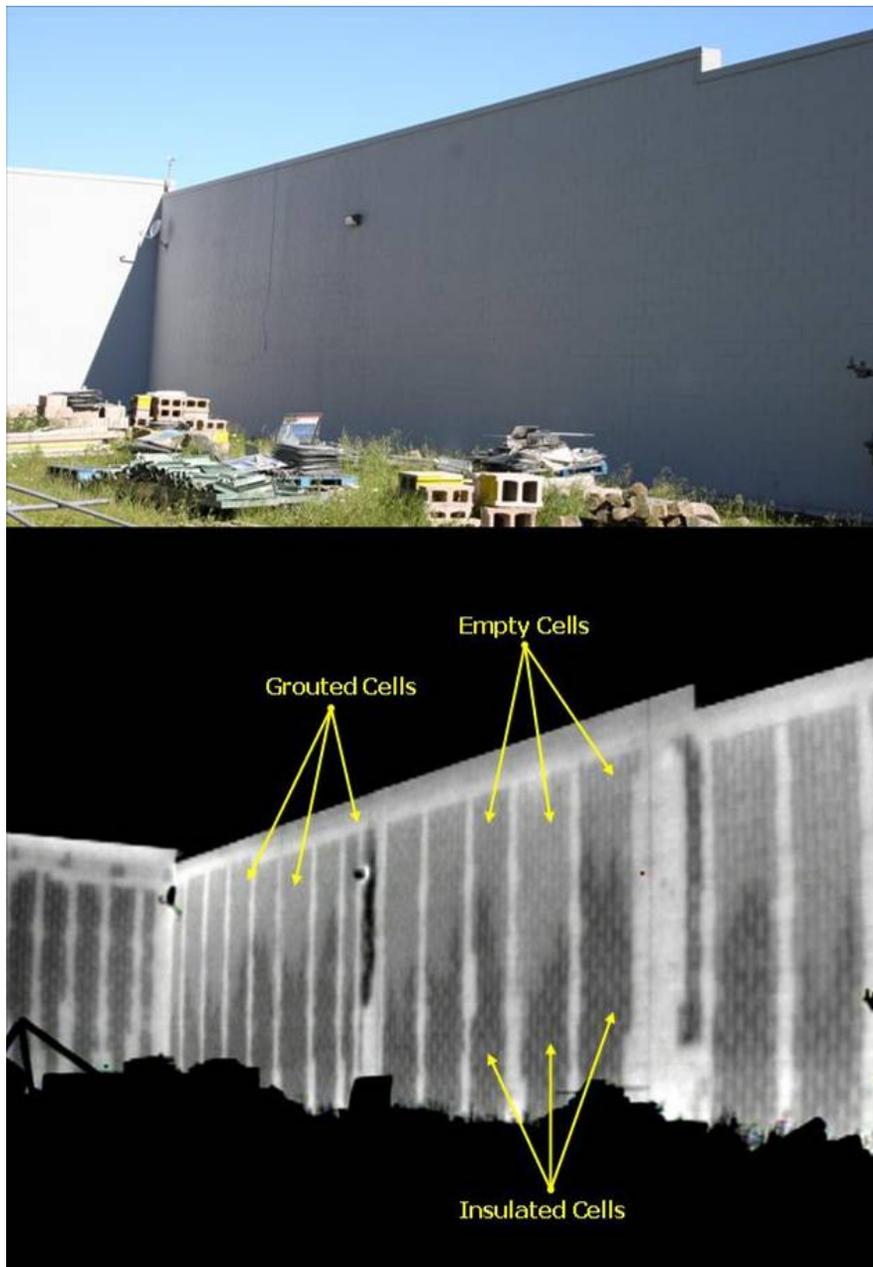
Figure 15. Infrared and visual image of a CMU wall showing that grouted, empty and insulated cells have a different rate of heat dissipation.

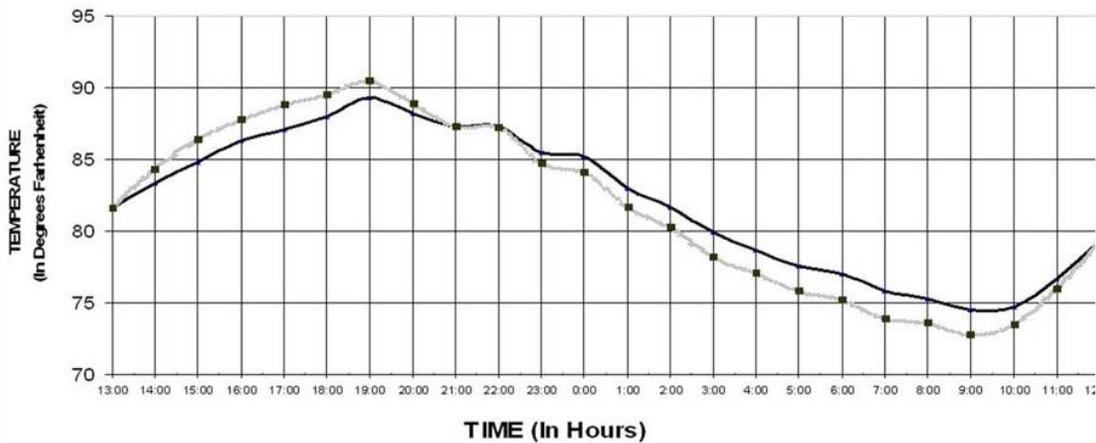
Figure 16. Time vs. Temperature Graph of a CMU wall over a 24-hour period.

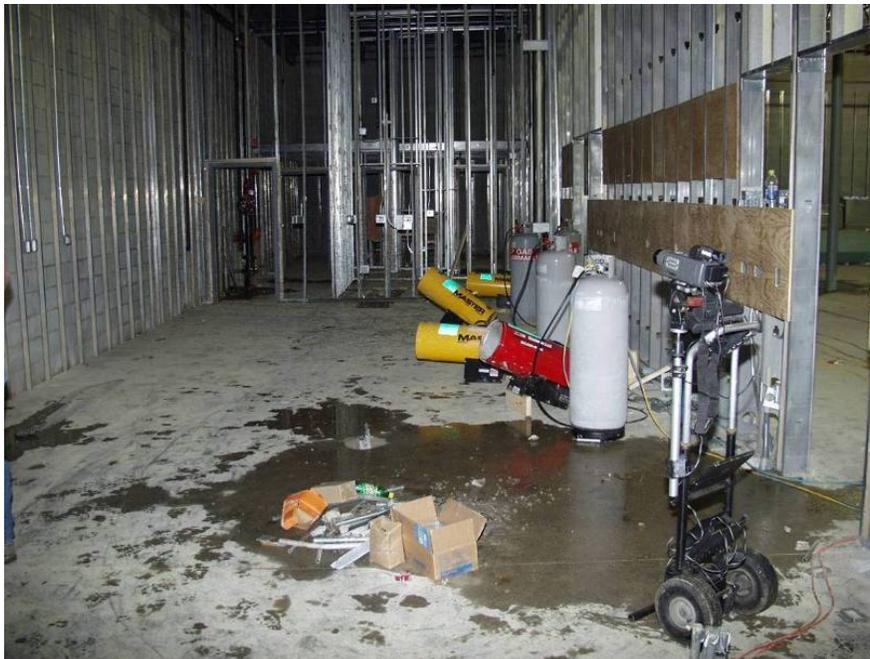
Figure 17. Visual image of a CMU wall being heated.

Block walls are erected on nearly every street corner as malls, schools, warehouses, retail stores, and every other kind of building. These walls often have reinforcing bars imbedded in grout-filled cells as a critical structural, weight-bearing component. By allowing the wall to absorb energy during the day and by watching the heat energy dissipate at night, the building IR thermographer can use the thermal image of the wall to define exactly where the grouted cells are located (see Figure 15). A time vs. temperature graph of a typical CMU wall (see Figure 16) over a 24-hour period shows how grouted and non-grouted areas heat and cool at different rates. Unfortunately, all walls cannot always be surveyed under ideal conditions. For instance, during some times during the year, because of the orientation of the building and/or low angle of the Sun to the building, some walls do not receive direct sunlight at any time during the day. Inside walls never receive any direct sunlight but often can still be surveyed because the ambient temperature changes. Also, the walls can be heated (see Figure 17) to achieve the desired delta-T.

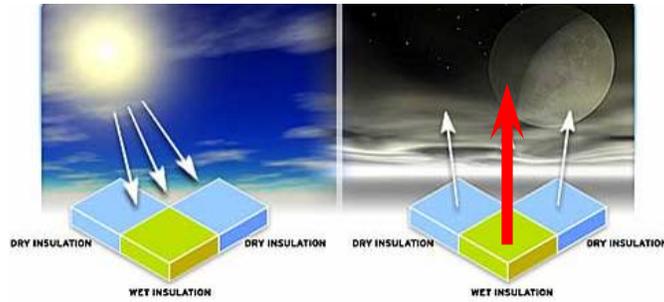
Figure 18. Representation of daily radiational heating and cooling cycle.

Infrared thermography can be used to find this entrained moisture. During the day, the sun radiates energy onto the roof and into the roof substrate, and then at night, the roof radiates the heat back into outer space. This is called radiational cooling. Areas of the roof that are of a higher mass (wet) retain this heat longer than that of the lower mass (dry) areas. Infrared imagers can detect this heat and "see" the warmer, higher mass areas, during the window of uneven heat dissipation (see Figure 18). Infrared roof moisture surveys can be performed by flying over the roof or walking over the roof. The same laws of physics apply to both on-roof IR and aerial IR. A dry roof, low winds, clear skies and no rain are needed on the night of the survey.

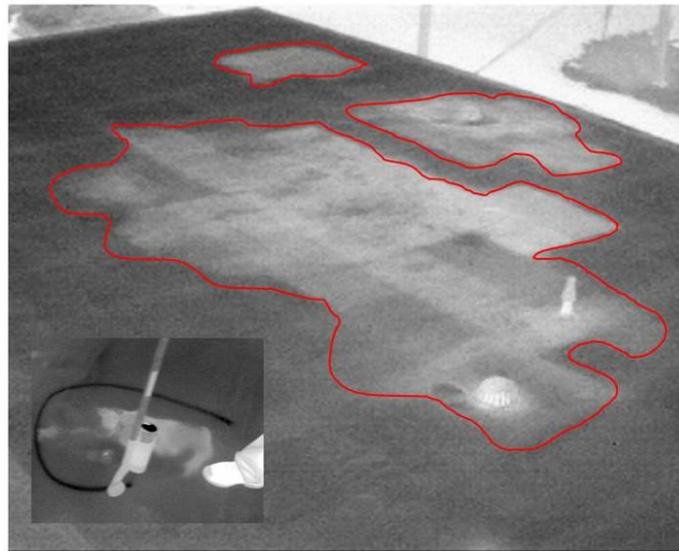
Figure 19. On-roof infrared image of a wet area on a flat roof highlighted by the red line.

For on-roof surveying, the thermographer walks around the roof and marks the wet spots with marking paint, so that repairman can patch the wet areas (see Figure 19). Aerial IR roof moisture surveys provide plan view visual photographs and infrared thermographs (see Figure 20) used to produce CAD drawings of the wet areas.

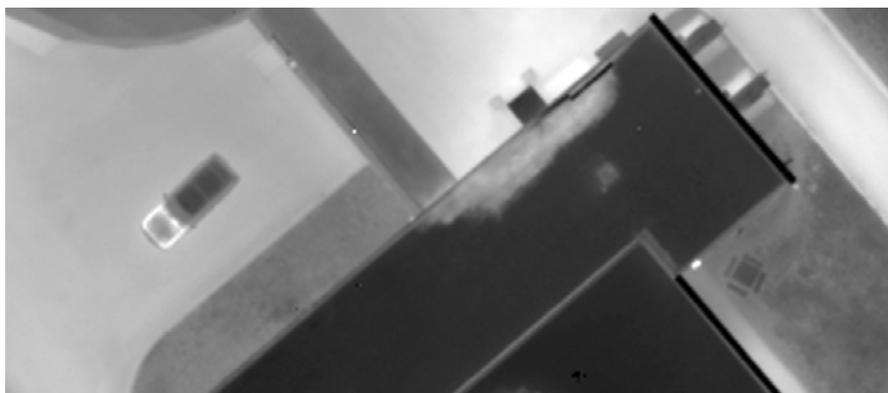
Figure 20. 10cm aerial IR image of a roof.
